# Sustainable Site Management Assessment Report

## First Baptist (Brick-a-Day) Church

Partner Organizations - CPCR, TU, AAACRHSC  
Pilot Project - Summer 2022

#### Property Condition Assessment

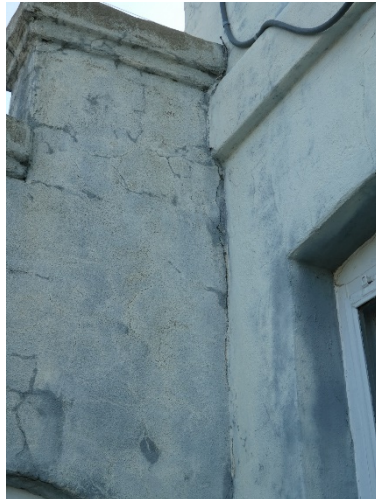
**Figure 45.**

Cracked and spalling cement parge coating and underlying masonry at stairs.

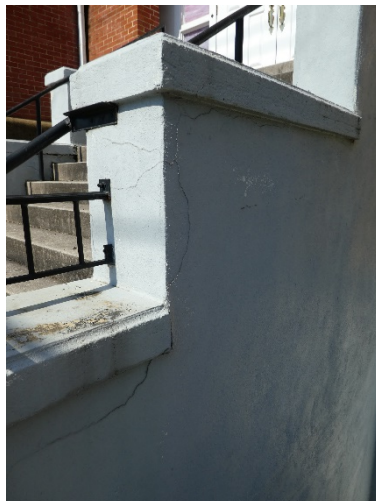
**Figure 46.**

Cracked and spalling cement parge coating and underlying masonry at stairs and foundation wall.

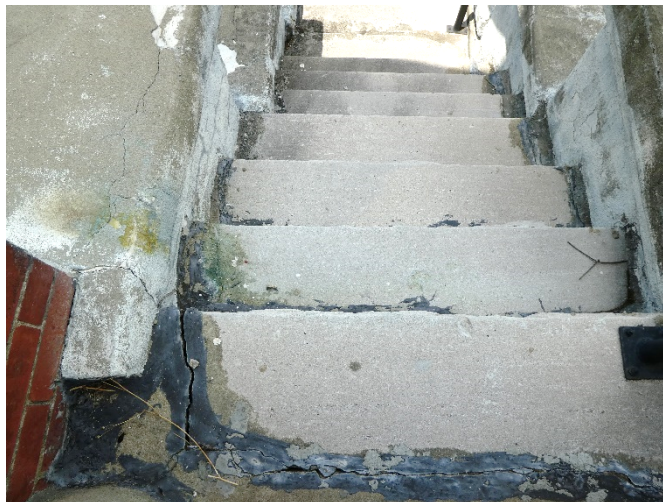
**Figure 47.**

Cracked and spalling cement parge coating and underlying masonry at stairs.

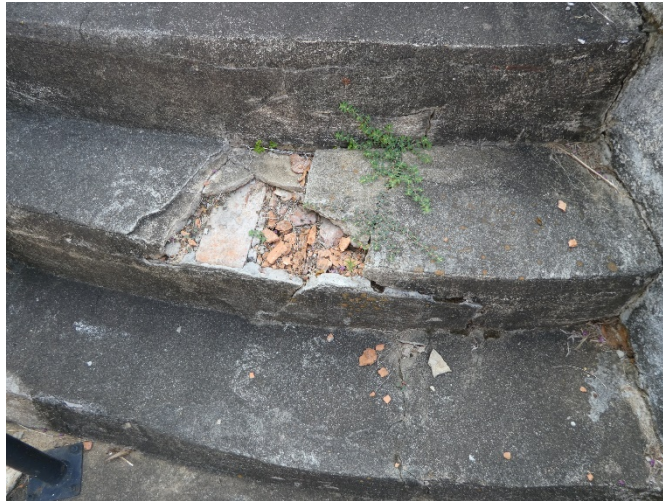
**Figure 48.**

Cracked and spalling cement parge coating and underlying masonry at stairs.

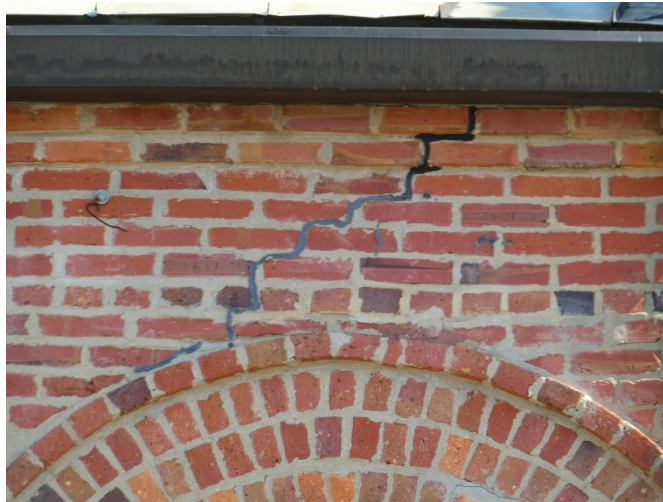
**Figure 49.**

Deteriorated mortar joints at brick masonry.

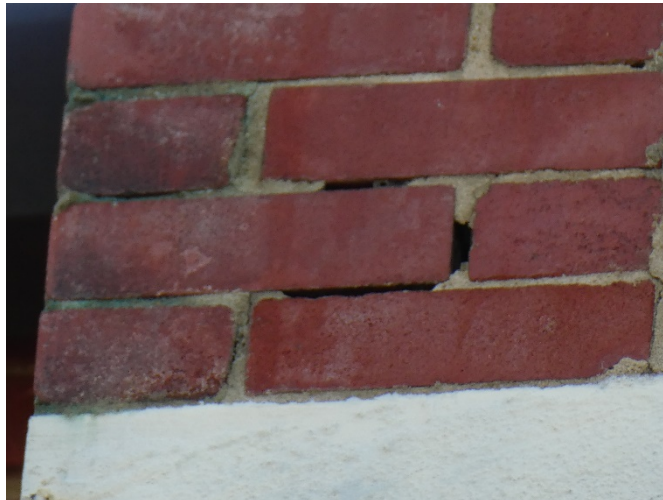
**Figure 50.**

Deteriorated mortar joints at brick masonry.

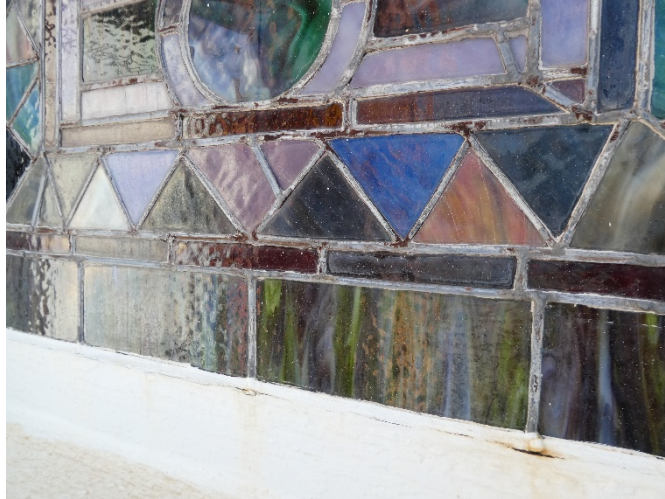
**Figure 66.**

Minor corrosion at stained glass steel framing and separating putty.

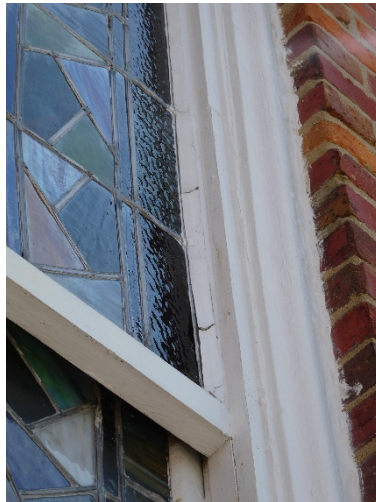
**Figure 67.**

Deteriorated putty.

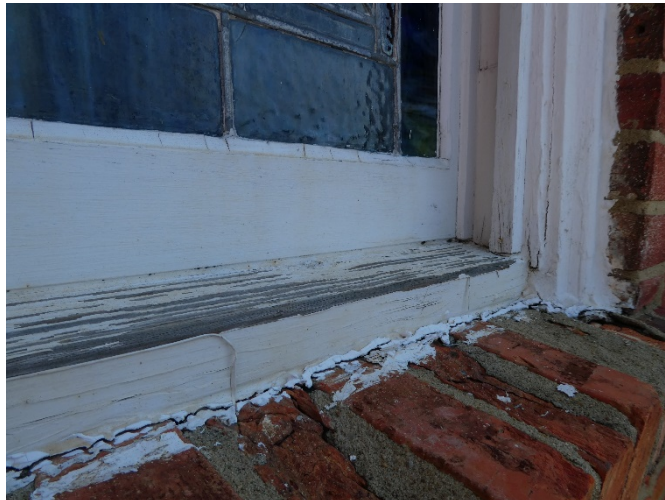
**Figure 68.**

Peeling paint, deteriorated putty and deteriorated perimeter sealant.

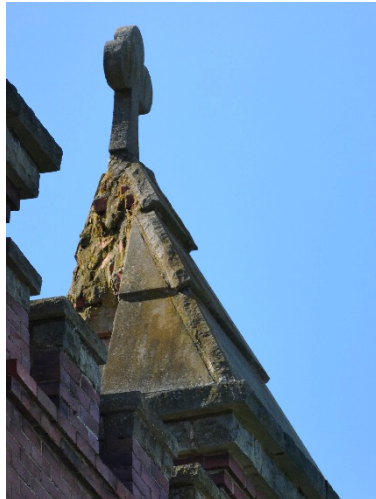
**Figure 78.**

Cracked and deteriorated stone spires and finials at belltower.

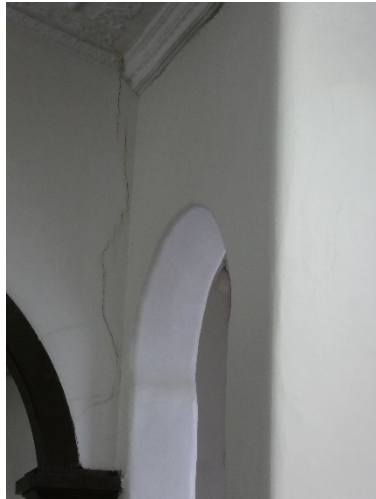
**Figure 84.**

Cracked and damaged plaster at interior sanctuary wall.

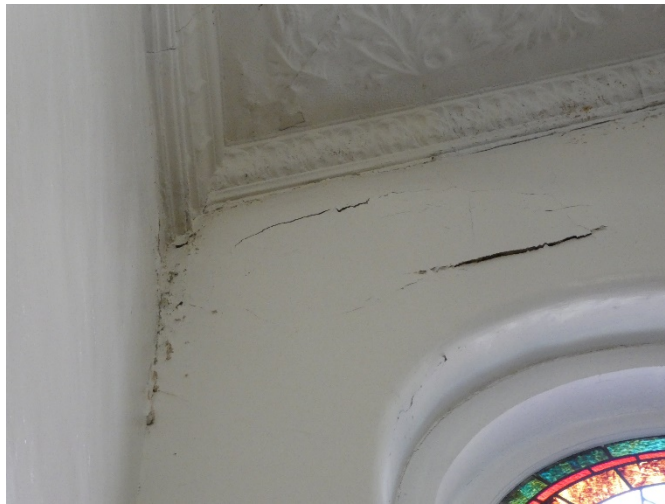
**Figure 85.**

Cracked and damaged plaster at interior sanctuary wall.

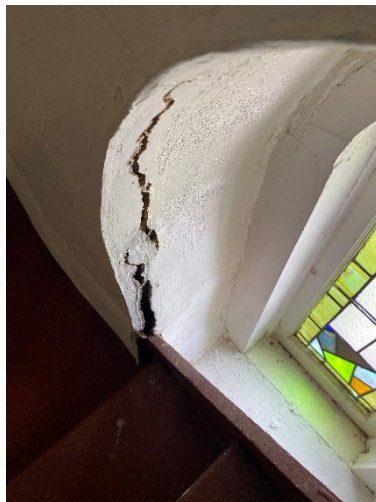
**Figure 86.**

Cracked and damaged plaster at north interior wall at belltower staircase.

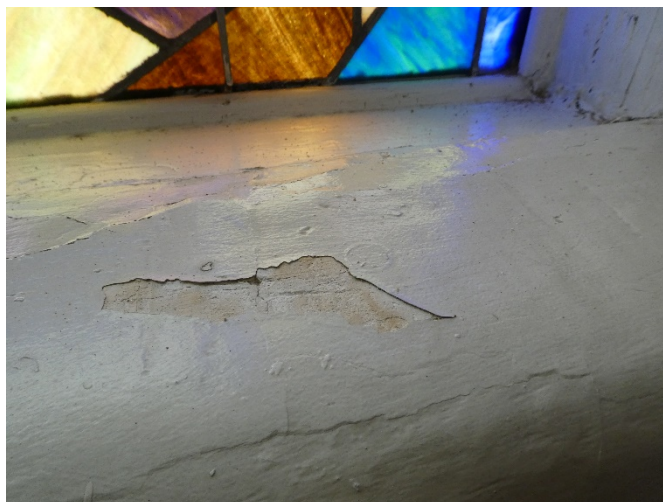
**Figure 87.**

Water damage at interior sanctuary wall.

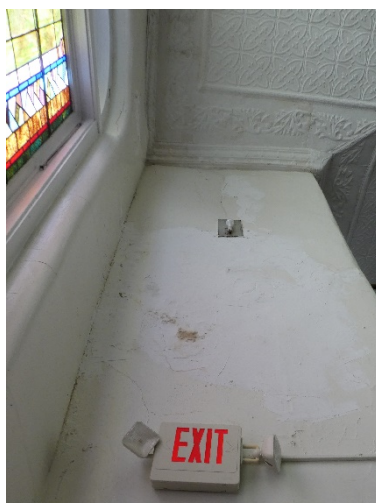
**Figure 88.**

Water damage at interior sanctuary walls.

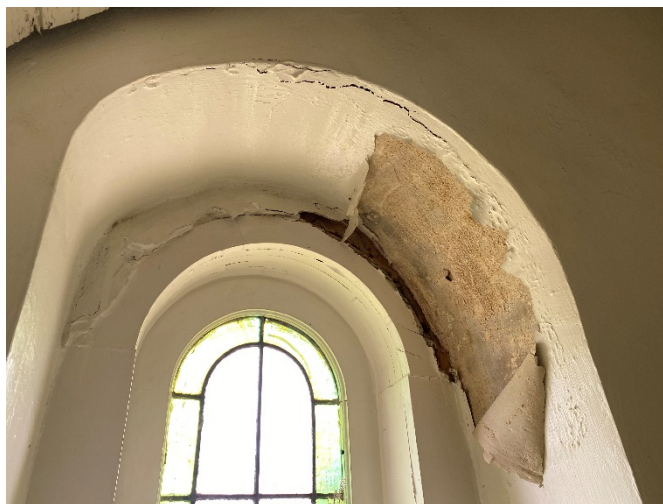
**Figure 89.**

Water damage at interior walls.

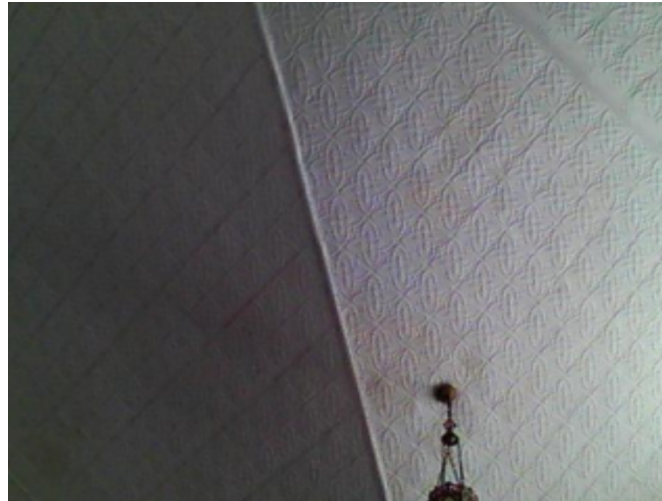
**Figure 93.**  
Interior water damage at quatrefoil tin ceiling in sanctuary.

Given the patterns of the staining and the infrared imagery, it appears that the damage at the interior ceilings is primarily located at the copper roof valleys and roof-to-exterior wall junctures. From our review, it appears that previous repairs to the roof did not fully address the water infiltration. Additional water damage was noted primarily at the interiors adjacent to window and door openings.

Based on the conditions observed on site and noted by the Church personnel, a consultant should be retained to complete a leak investigation to determine where the roofing system is actively leaking and whether it is an issue primarily centered at the roof valleys, or if there are additional issues within the roofing system. The window and door assemblies should also be tested to determine if they are leaking due to openings within the frames, due to deteriorated perimeter sealant, and/or due to the current intersection of the headers and footers.
