# Sustainable Site Management Assessment Report

## First Baptist (Brick-a-Day) Church

Partner Organizations - CPCR, TU, AAACRHSC  
Pilot Project - Summer 2022

#### Property Condition Assessment

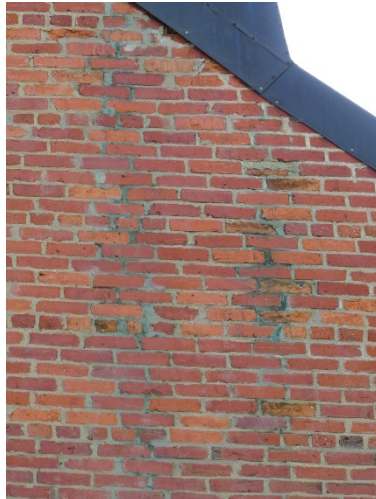
**Figure 54.**  
Biological growth at exterior walls.

**Figure 55.**  
Biological growth at exterior walls.

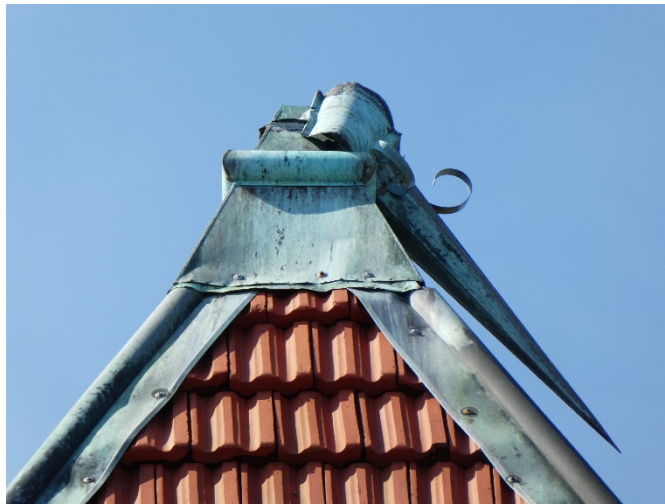
**Figure 77.**  
Detached copper finial at southeast tower.

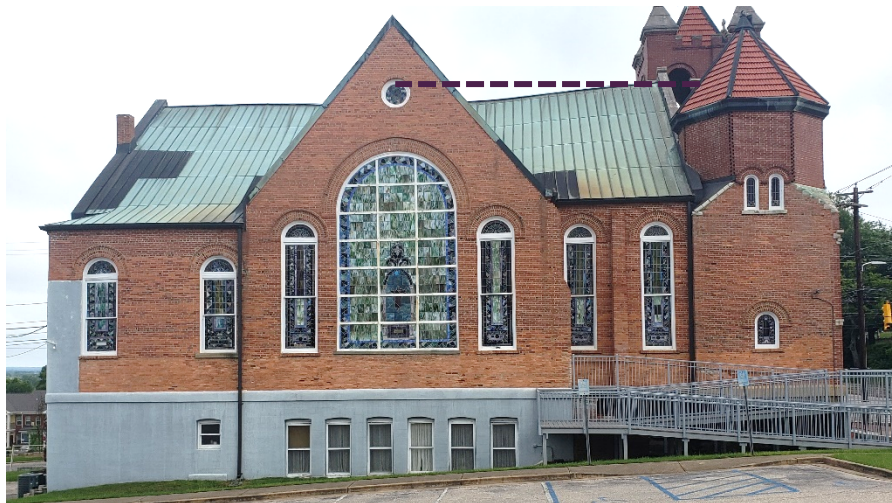
**Figure 79.**

Deflection at standing seam roof ridge. Note approximate datum line.

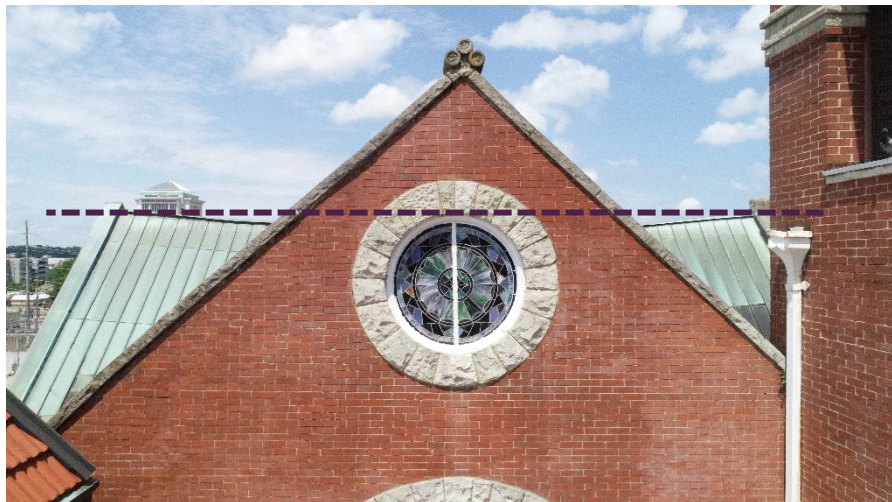
**Figure 80.**

Deflection at standing seam roof ridge. Note approximate datum line.

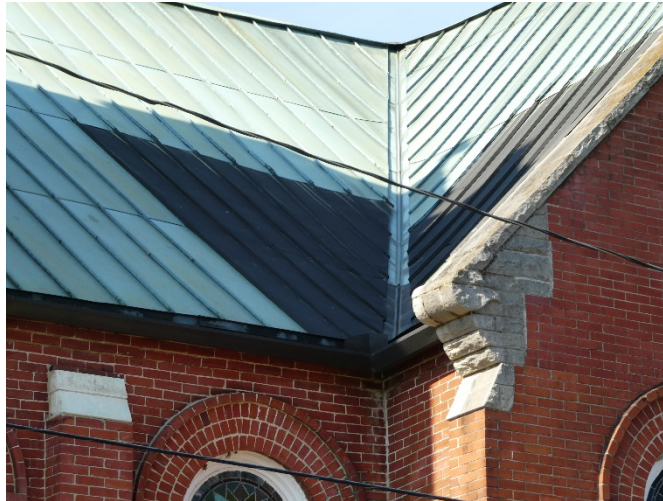
**Figure 82.**  
Previously patched area at standing seam roof. Note detached flashing at parapet wall.

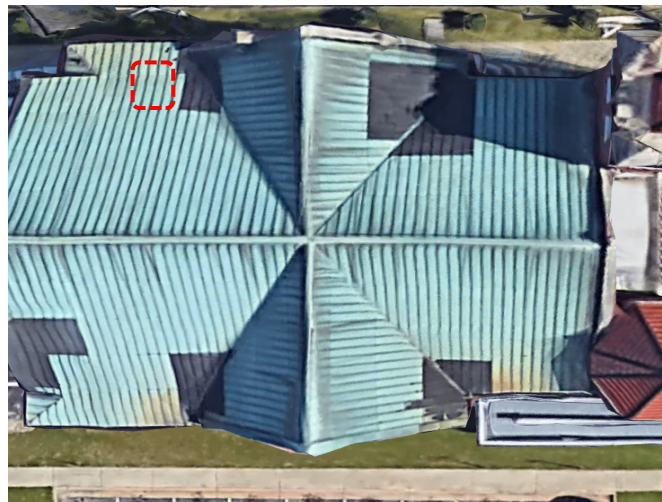
**Figure 101.**  
Exterior view of general area shown  
in Figures 99 and 100 (red dashed  
outline).
